TRANSPORTATION RESEARCH CENTER

**Indiana University
Bloomington, Indiana 47403-1599**

ON-SITE AIR BAG INVESTIGATION

**CASE NO. - 96-16
FLEET - PRIVATE VEHICLE
LOCATION -
ACCIDENT DATE -**

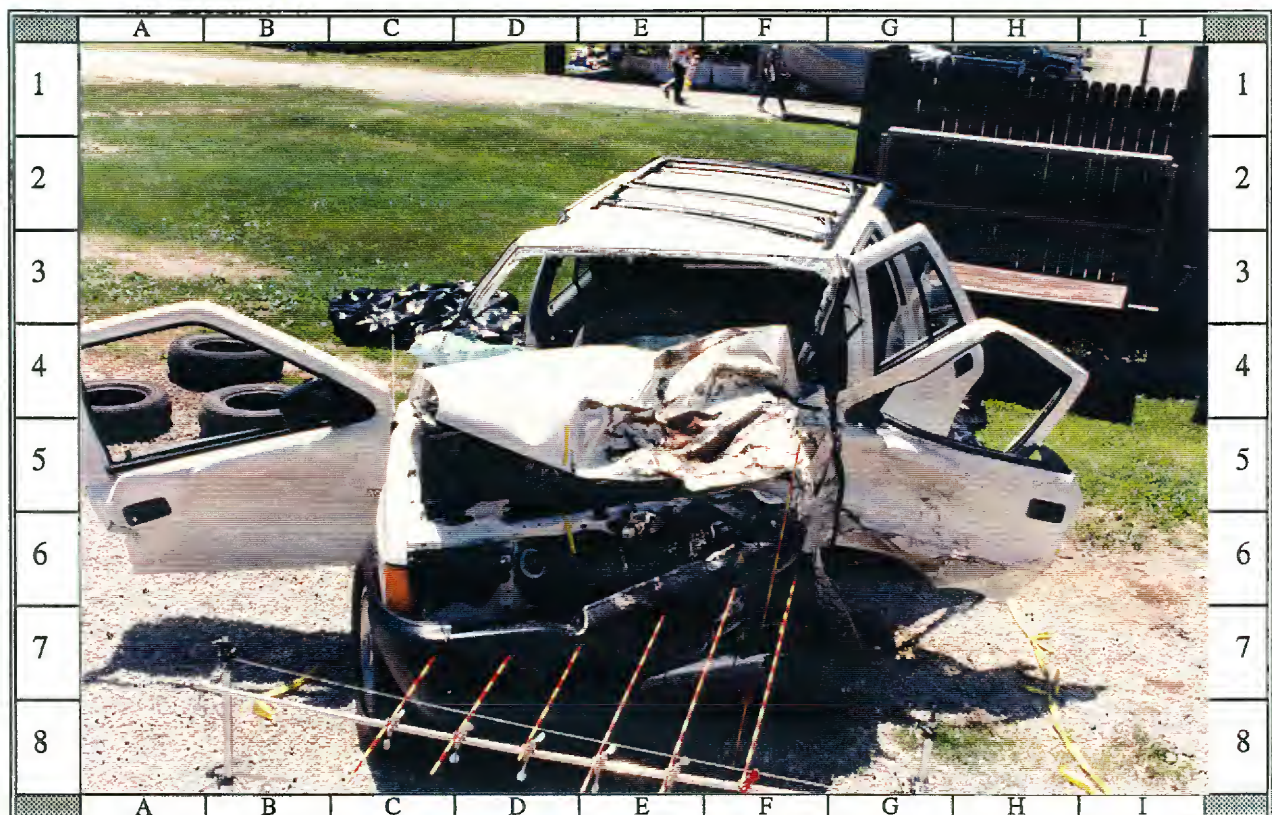
26: Front overhead view of Case Vehicle's front left damage viewed from ~ 30 degrees left of front; NOTE: direct damage extends to mid-left driver's door

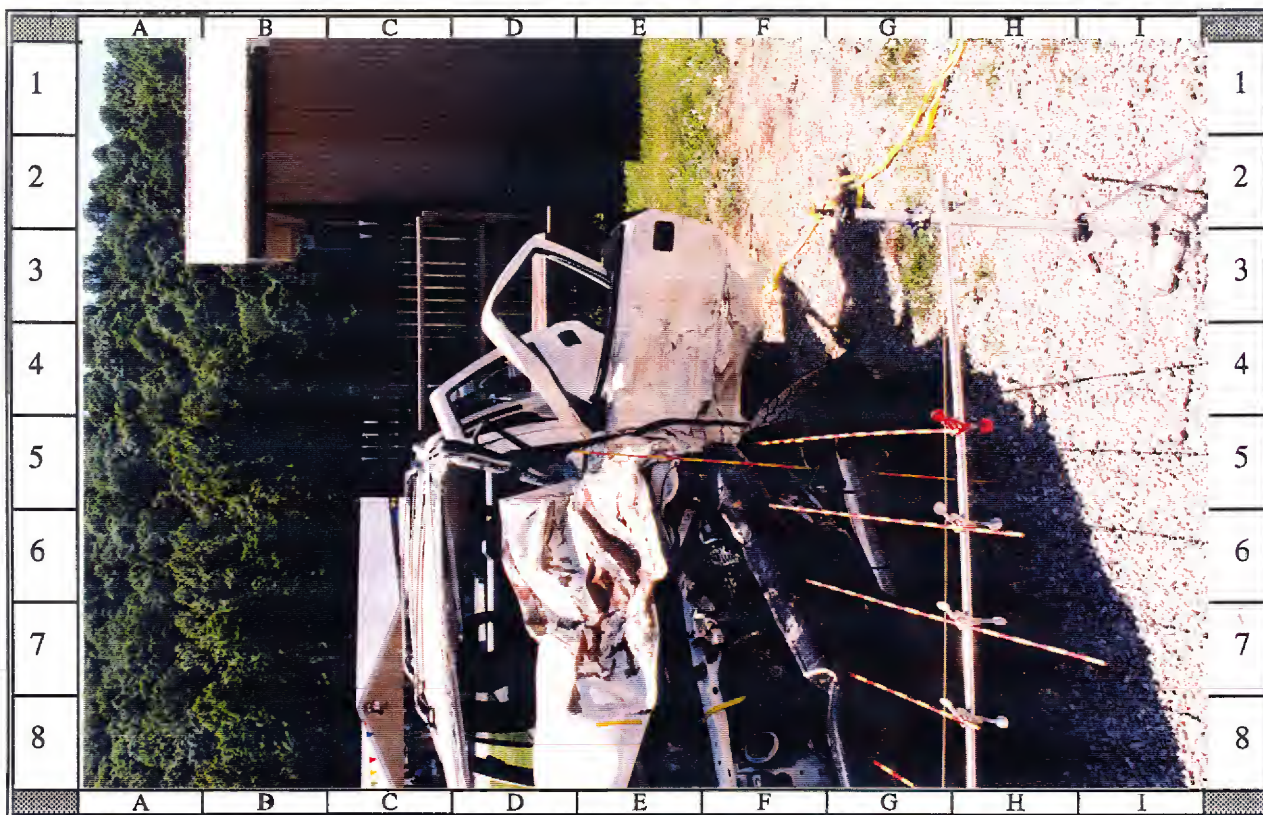
27: Reference line view of Case Vehicle's damaged front and left side viewed from front showing severe front left crush and left front door damage and tire position

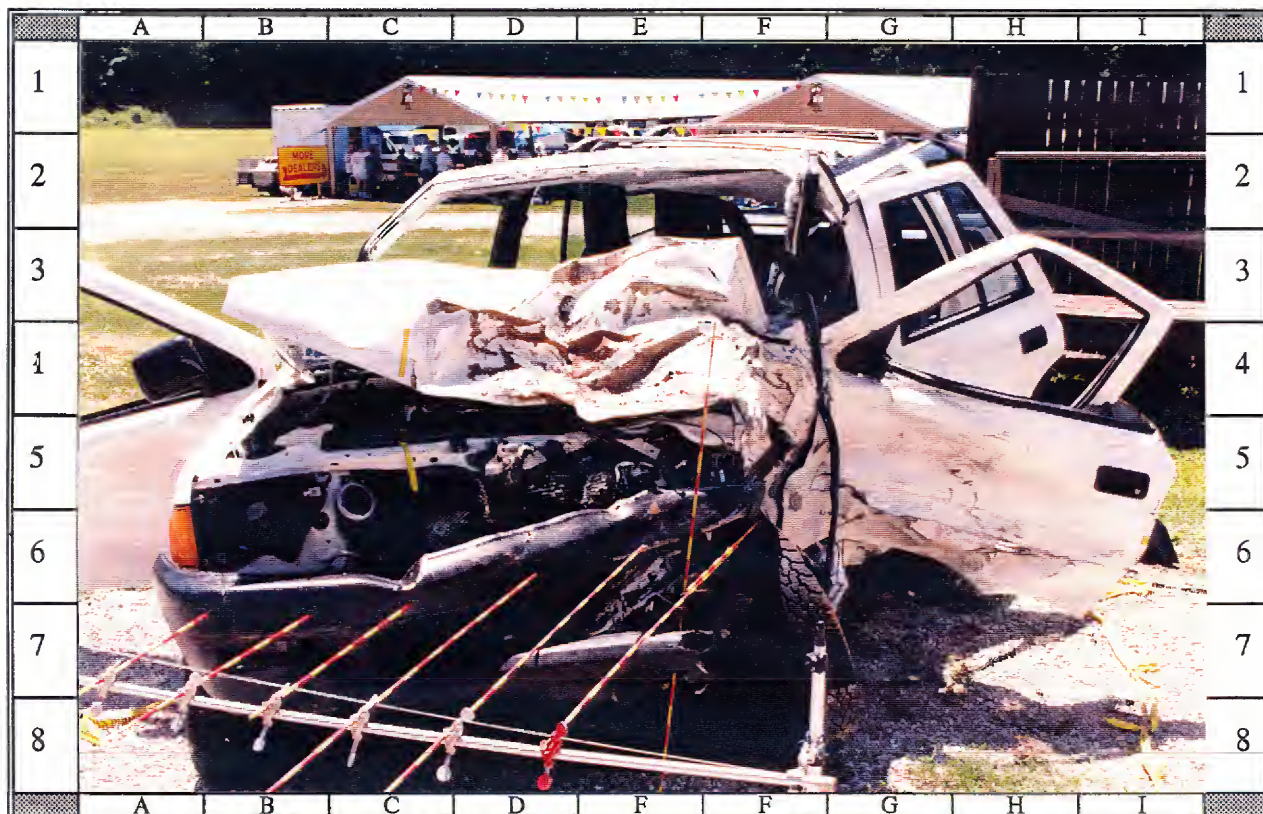
28: Case Vehicle's damaged front and left side viewed from approximately 30 degrees left of front with contour gauge present

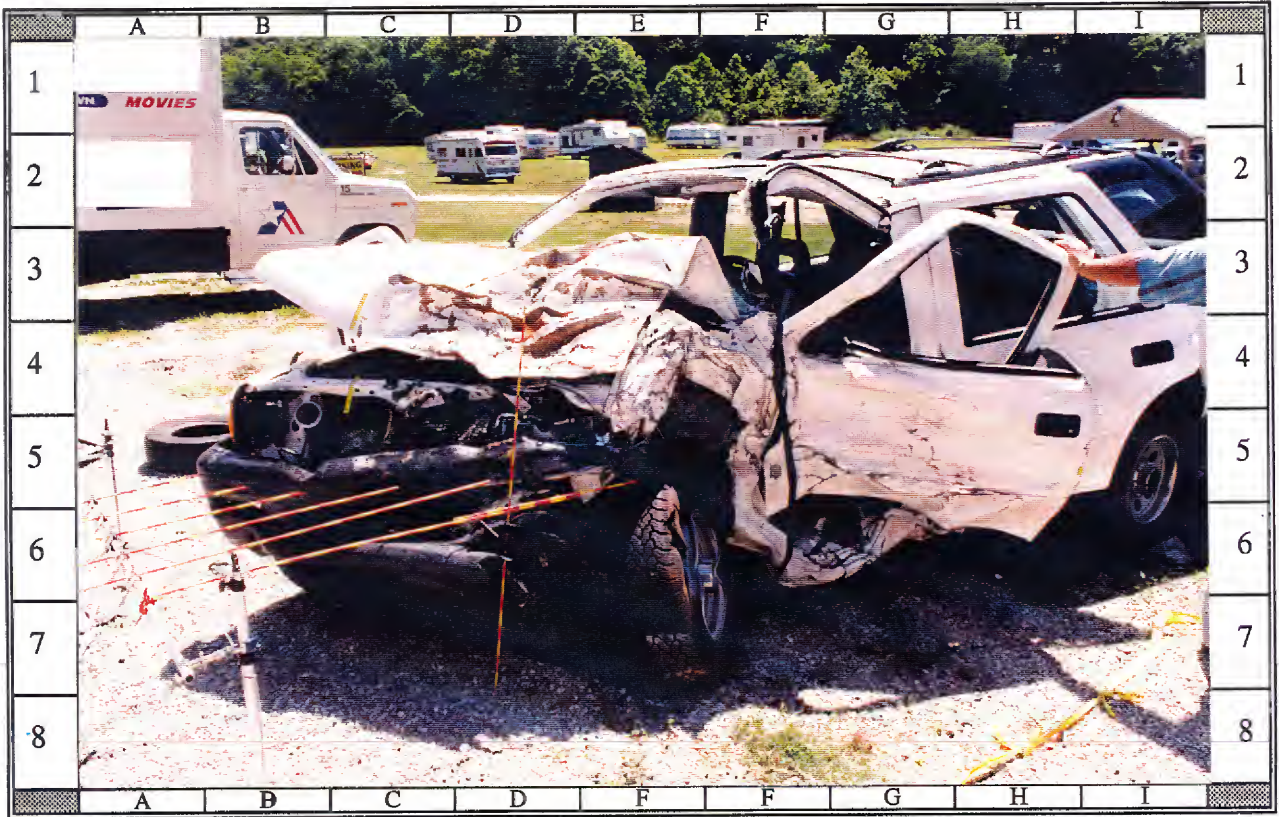
29: Case Vehicle's front left damage viewed from approximately 45 degrees left of front; NOTE: extensive crush and buckling of left front door sill

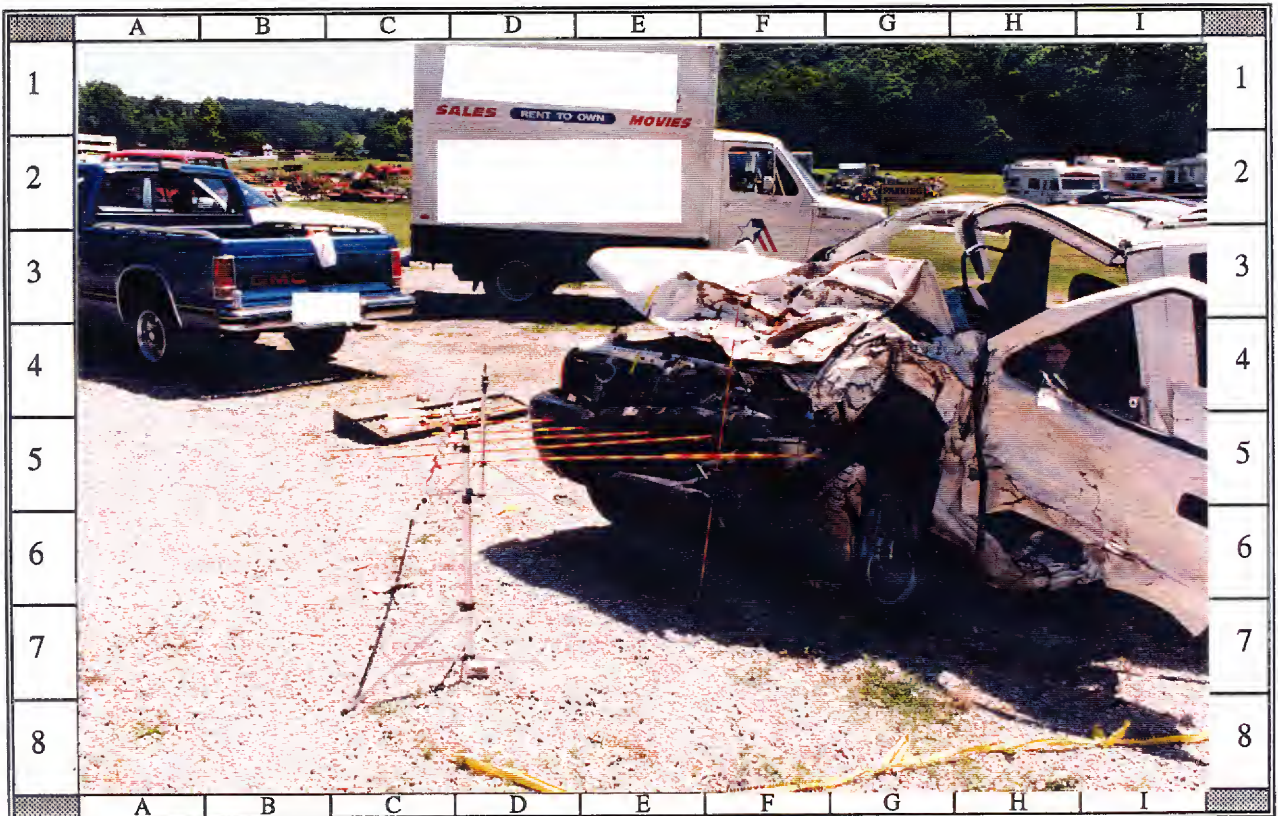
30: Reference line view of Case Vehicle's damaged front viewed from left showing extensive front left crush and direct damage to driver's door and left side rail

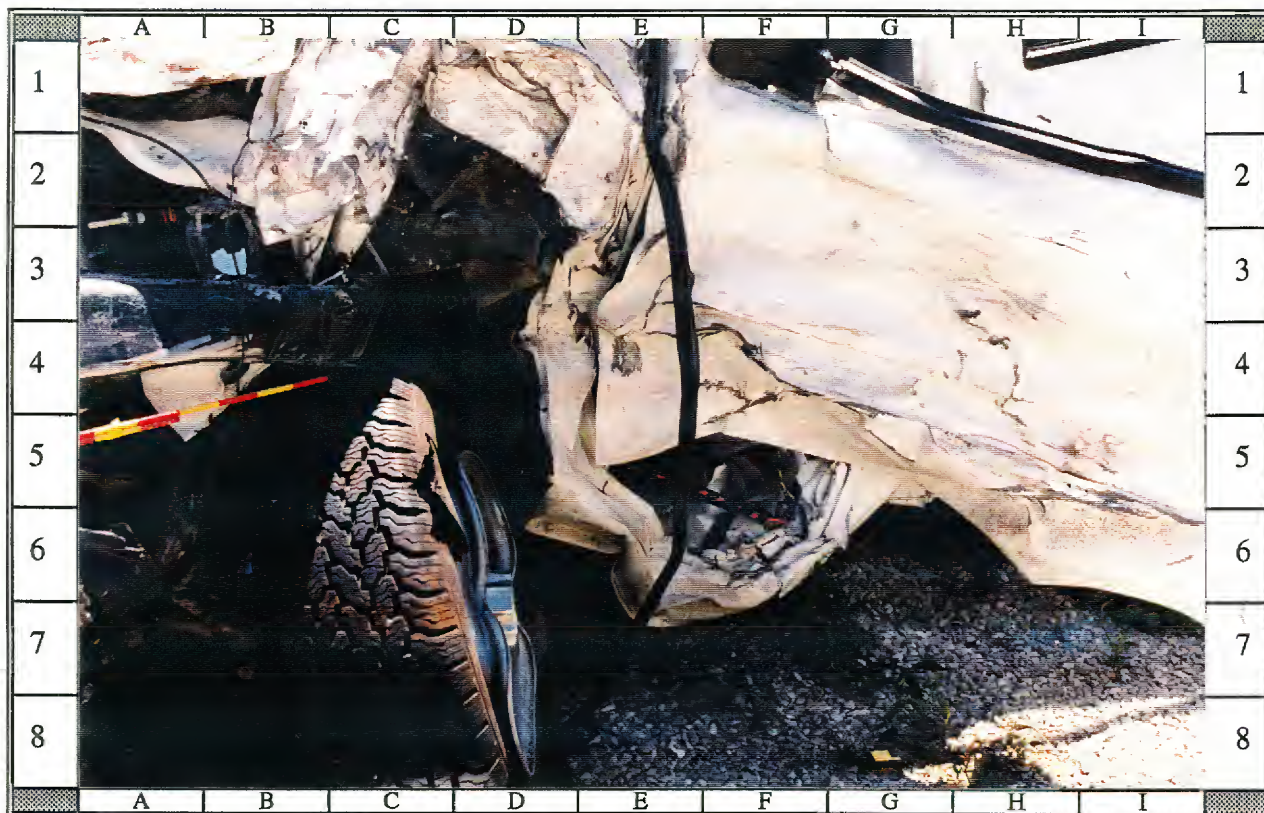
31: Close-up of Case Vehicle's left front tire and front left bumper corner; NOTE: direct damage to left front door and downward buckling to left front door sill

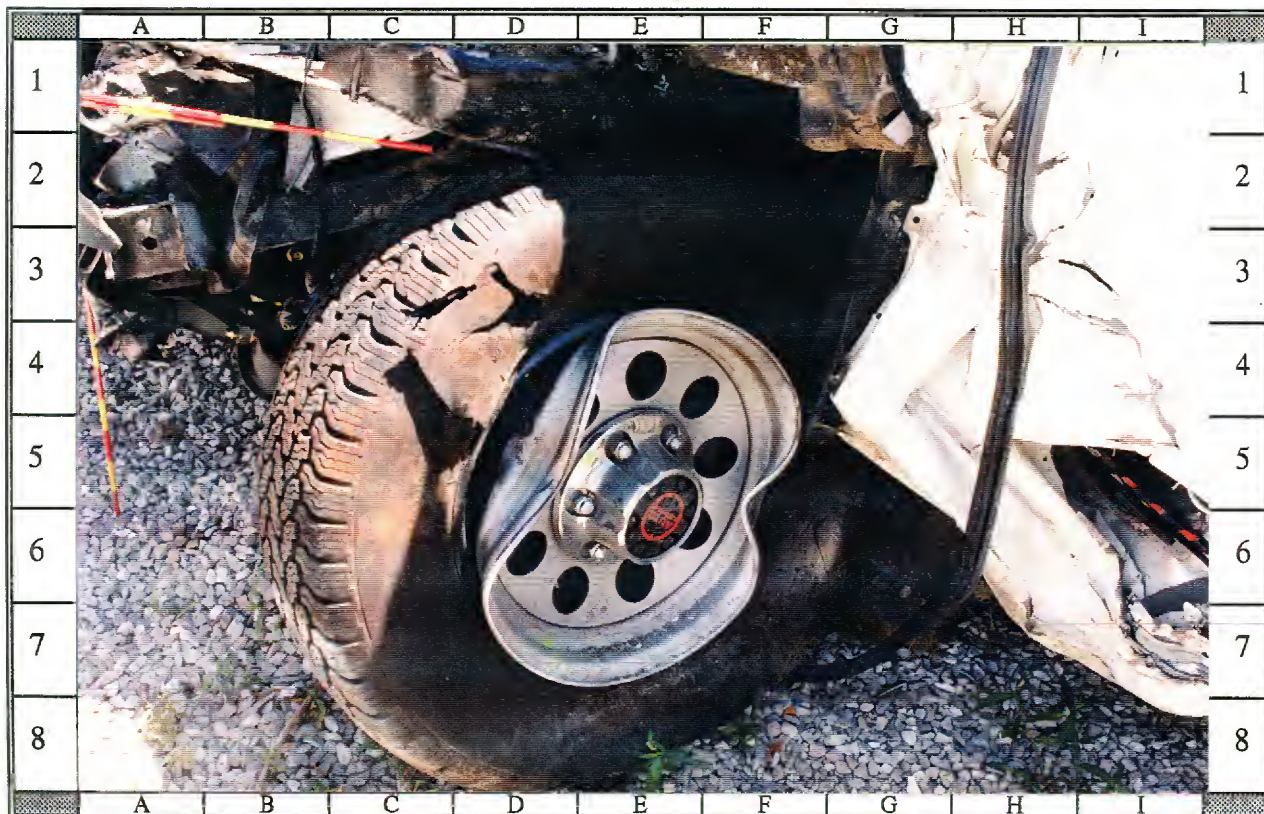
32: Close-up of Case Vehicle's damaged left front tire and wheel; NOTE: front wheel and rim damage from vehicle #2, rear damage from bottom of fire wall

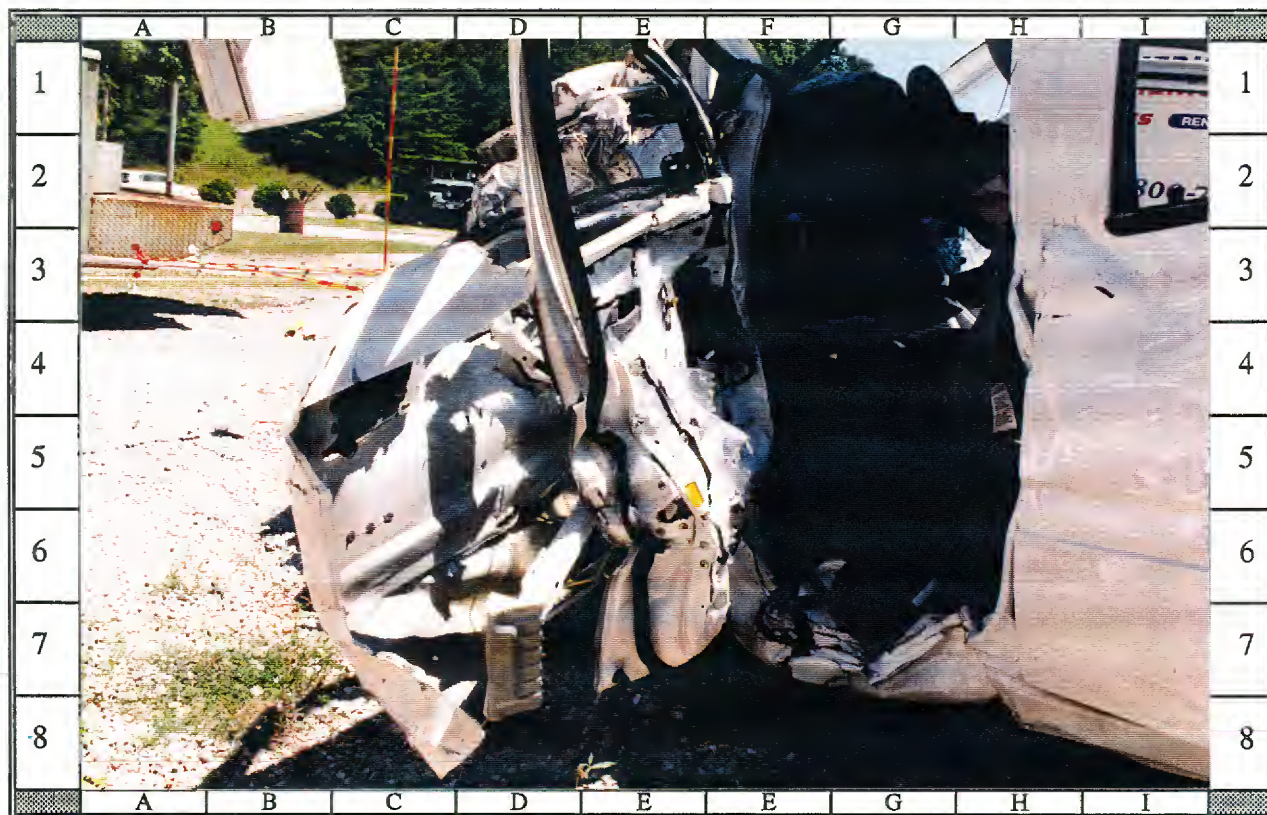
33: Case Vehicle's driver door viewed from approximately 45 degrees left of back showing separation of outer and inner door surfaces and extrication damage

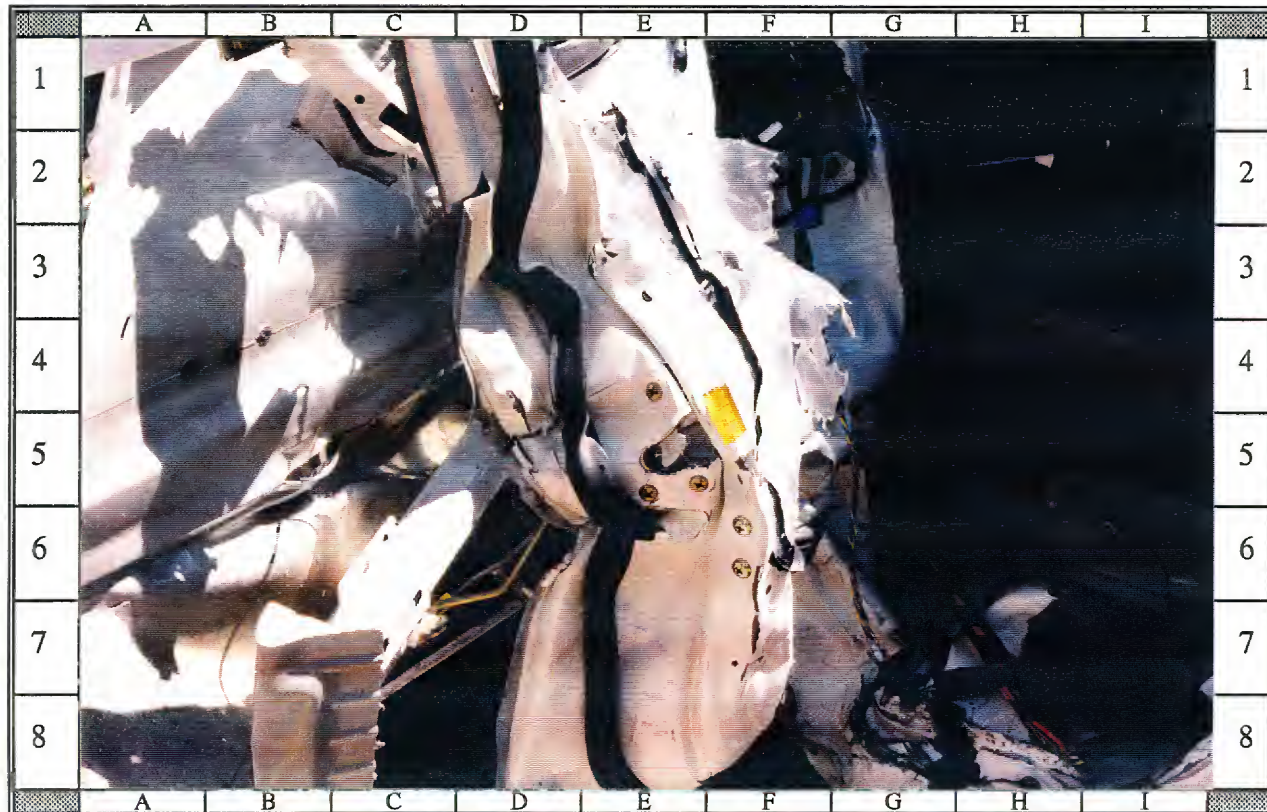
34: Close-up of rear surface of Case Vehicle's driver door; NOTE: extrication tool-induced damage and separation of outer and inner door surfaces

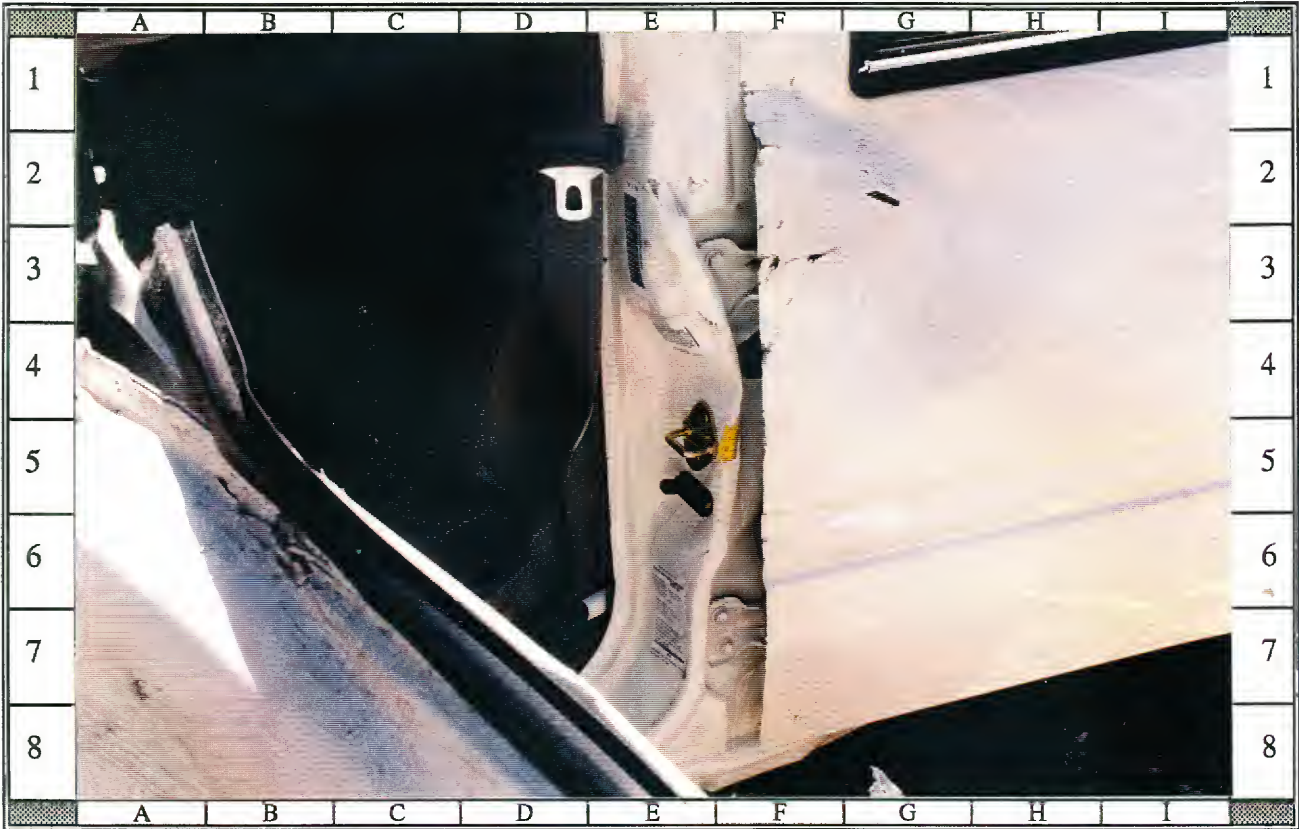
35: Latch plate for Case Vehicle's driver door showing lack of crash-induced deformation (at yellow tape) and extrication marks on left rear door's surface

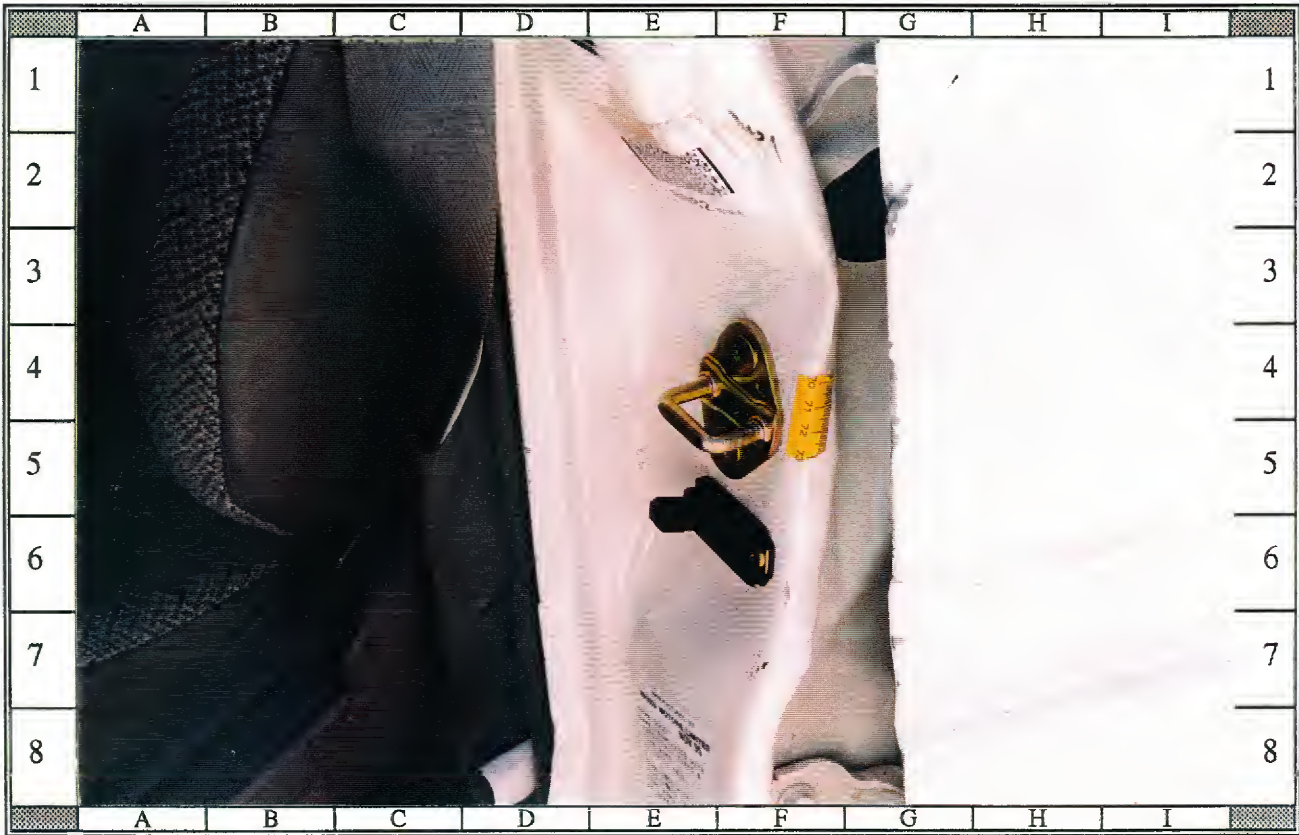
36: Close-up of latch plate for Case Vehicle's driver door; NOTE: no evidence of crash-induced deformation on latch plate

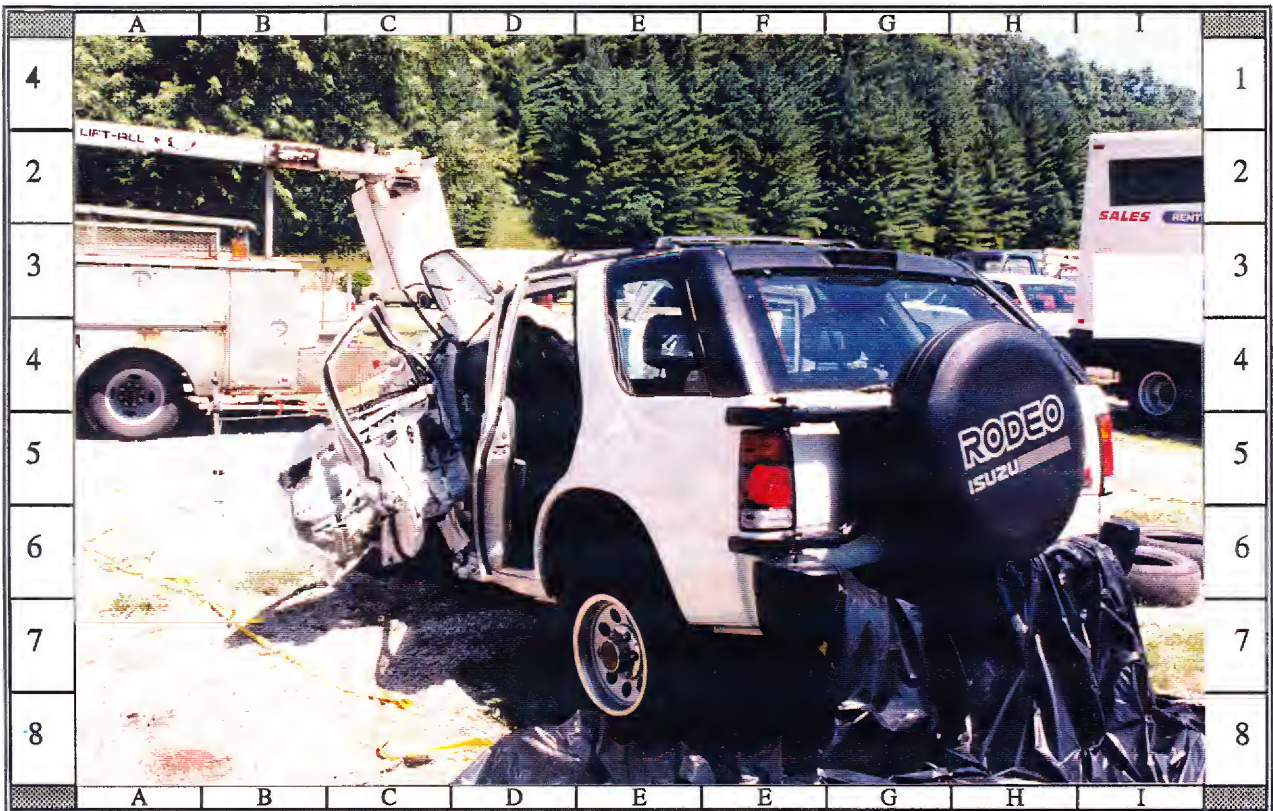
37: Case vehicle's left side and undamaged rear viewed from approximately 45 degrees left of back; NOTE: intact glazing rearward of left rear window

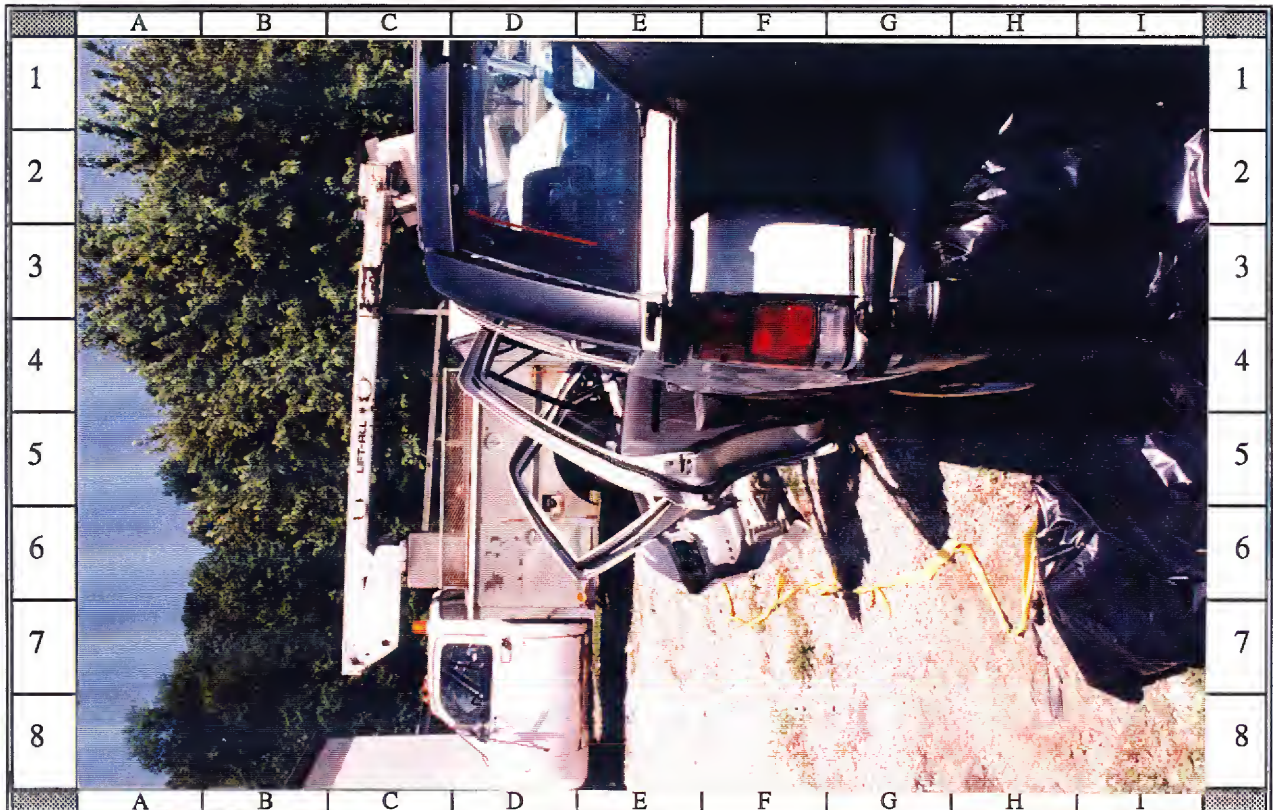
38: Reference line view of Case Vehicle's left side from back; NOTE: exterior sheet metal pulled away from the left front door panel

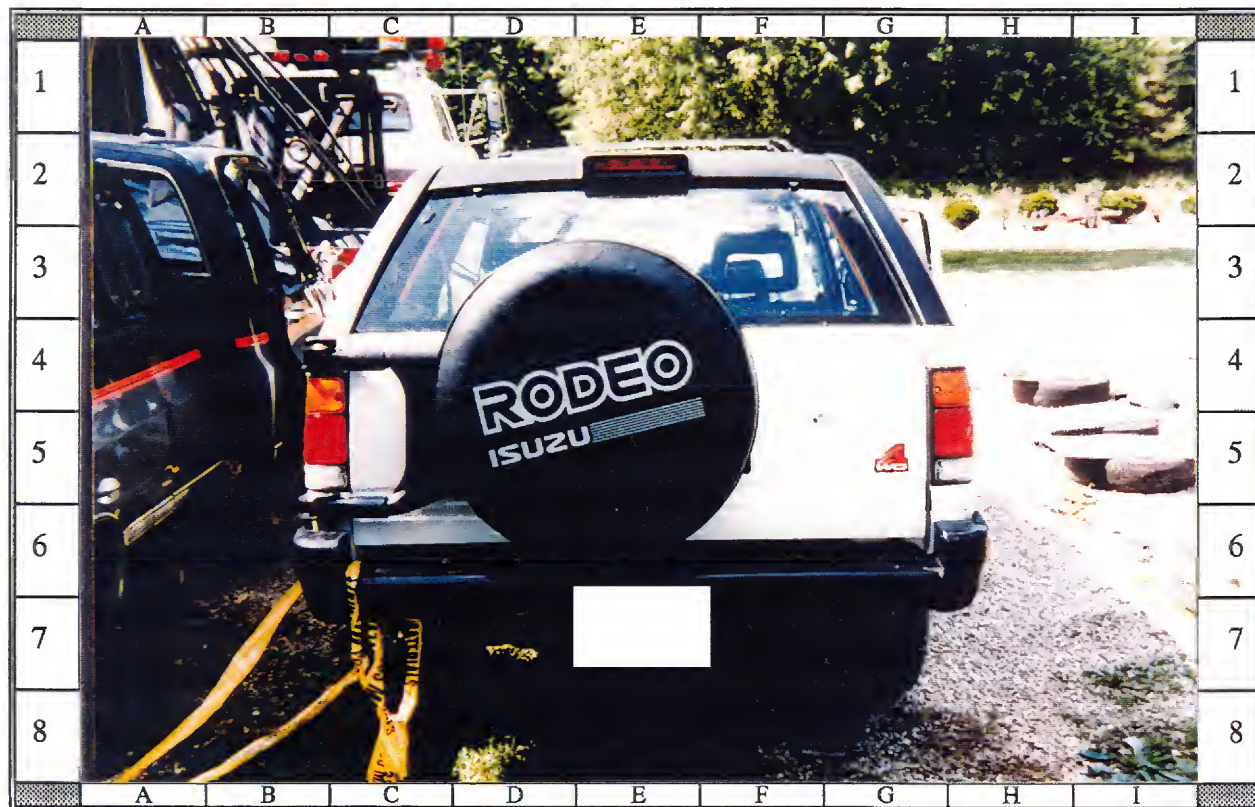
39: Case Vehicle's undamaged back plane showing four-wheel drive indicator and undamaged backlight

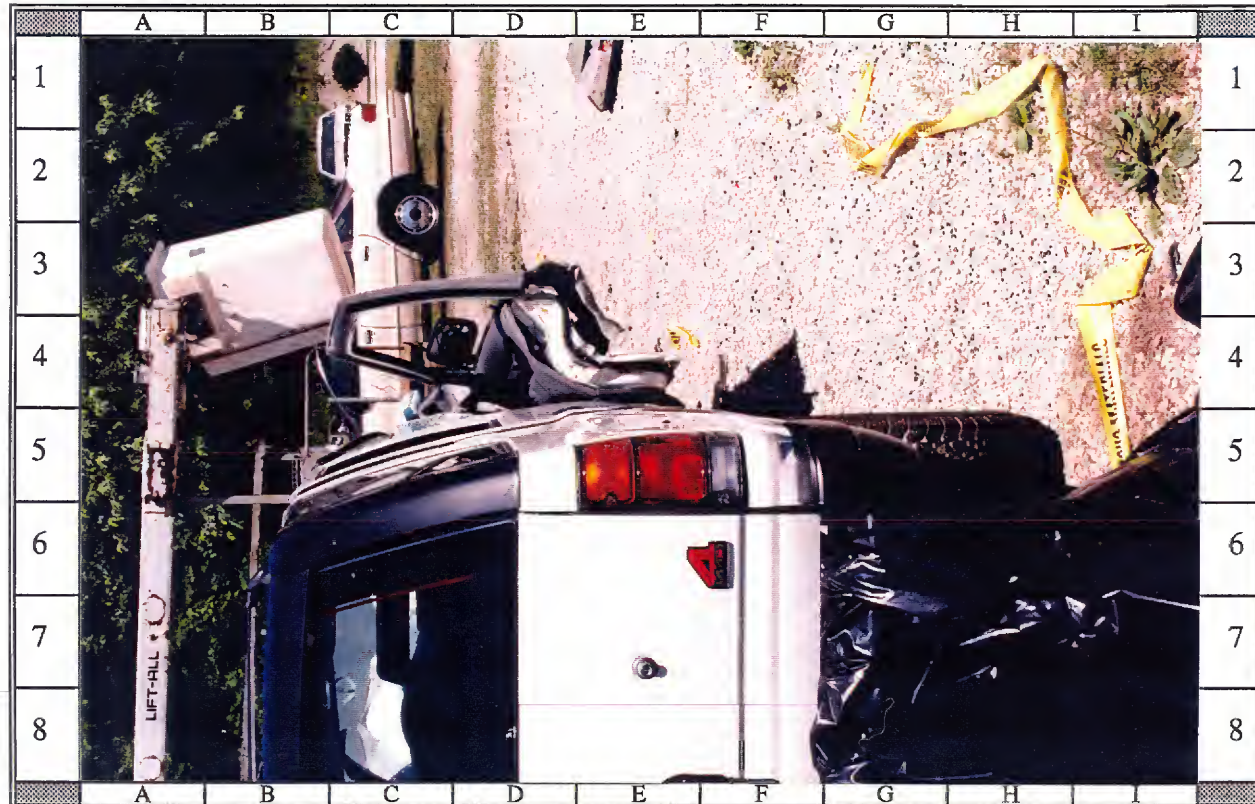
40: Reference line view of Case Vehicle's right side from back; NOTE: extrication tool-induced deformation to right front passenger door

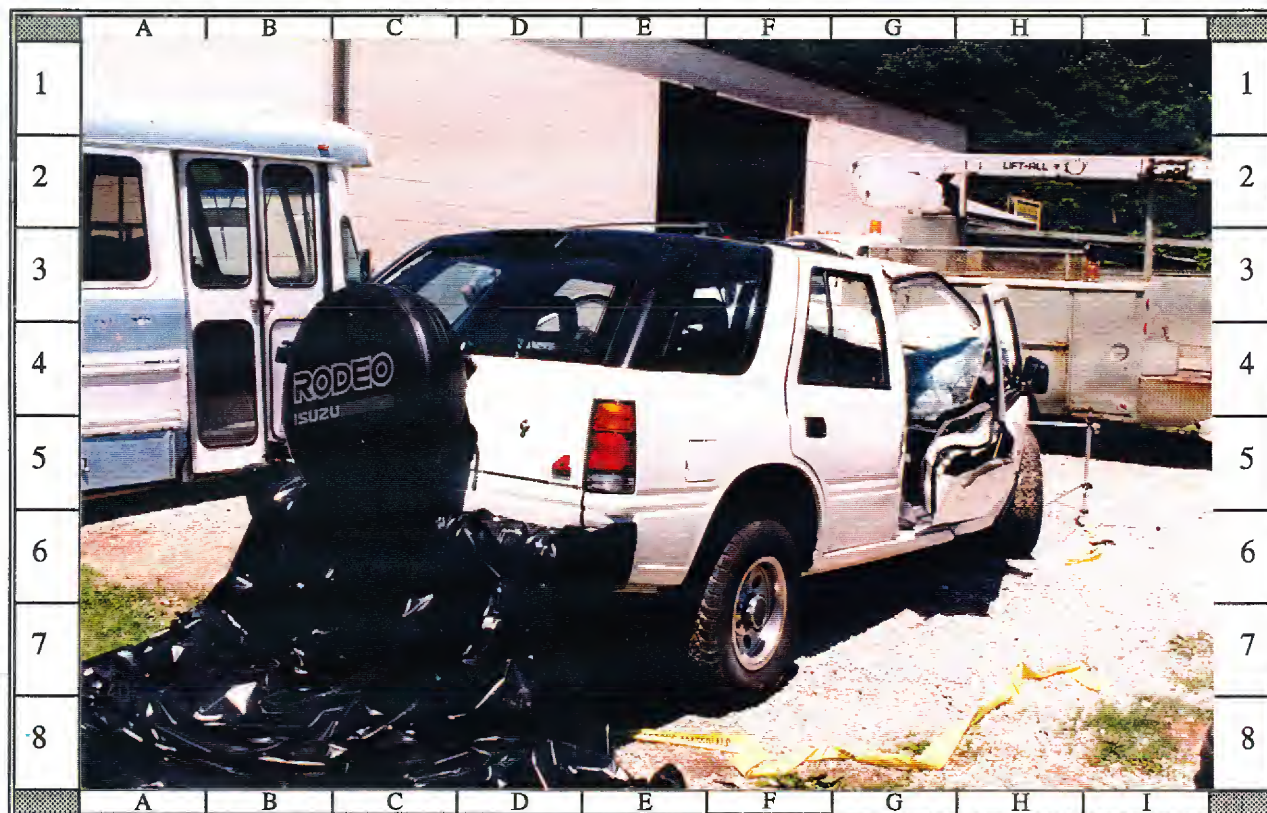
41: Case Vehicle's right side and undamaged back viewed from approximately 45 degrees right of back; NOTE: intact glazing rearward of right front window

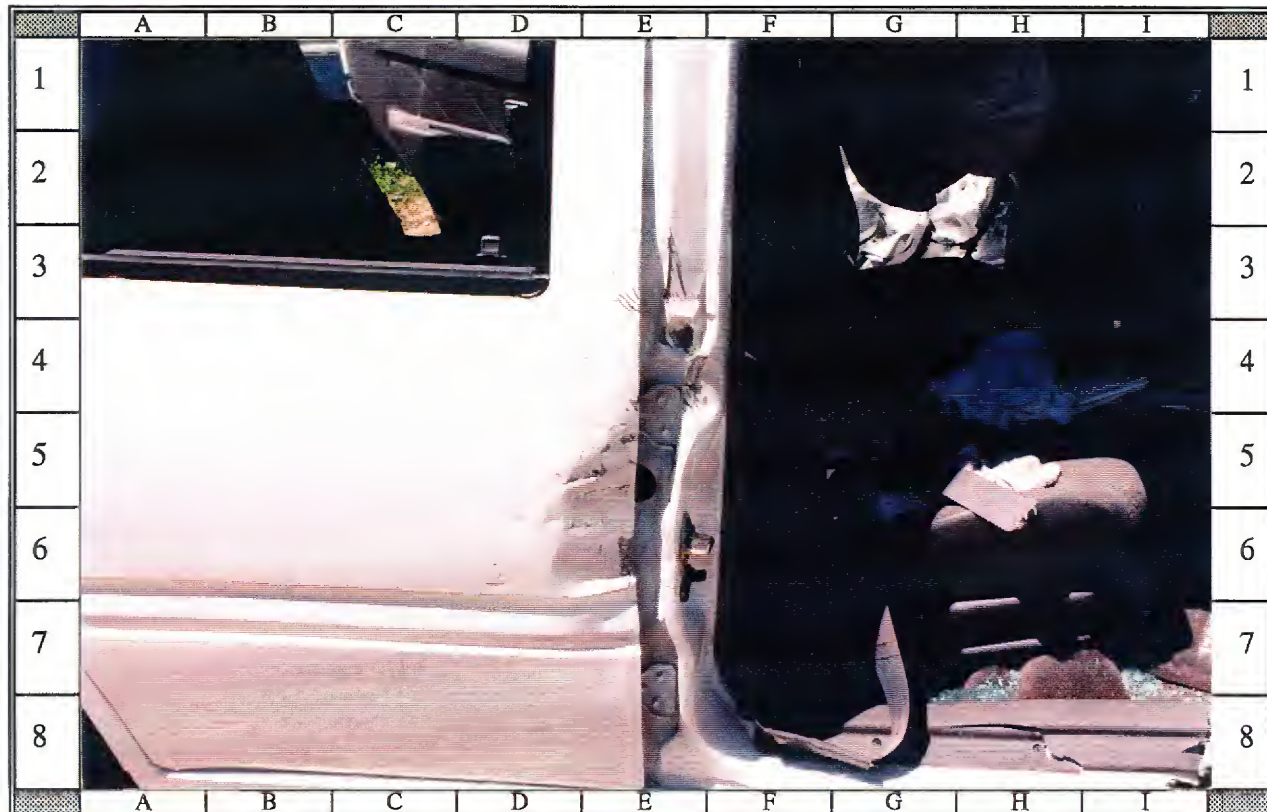
42: Close-up of Case Vehicle's lower right "B"-pillar; NOTE: extrication tool-induced damage to forward edge of right rear door and the lower "B"-pillar

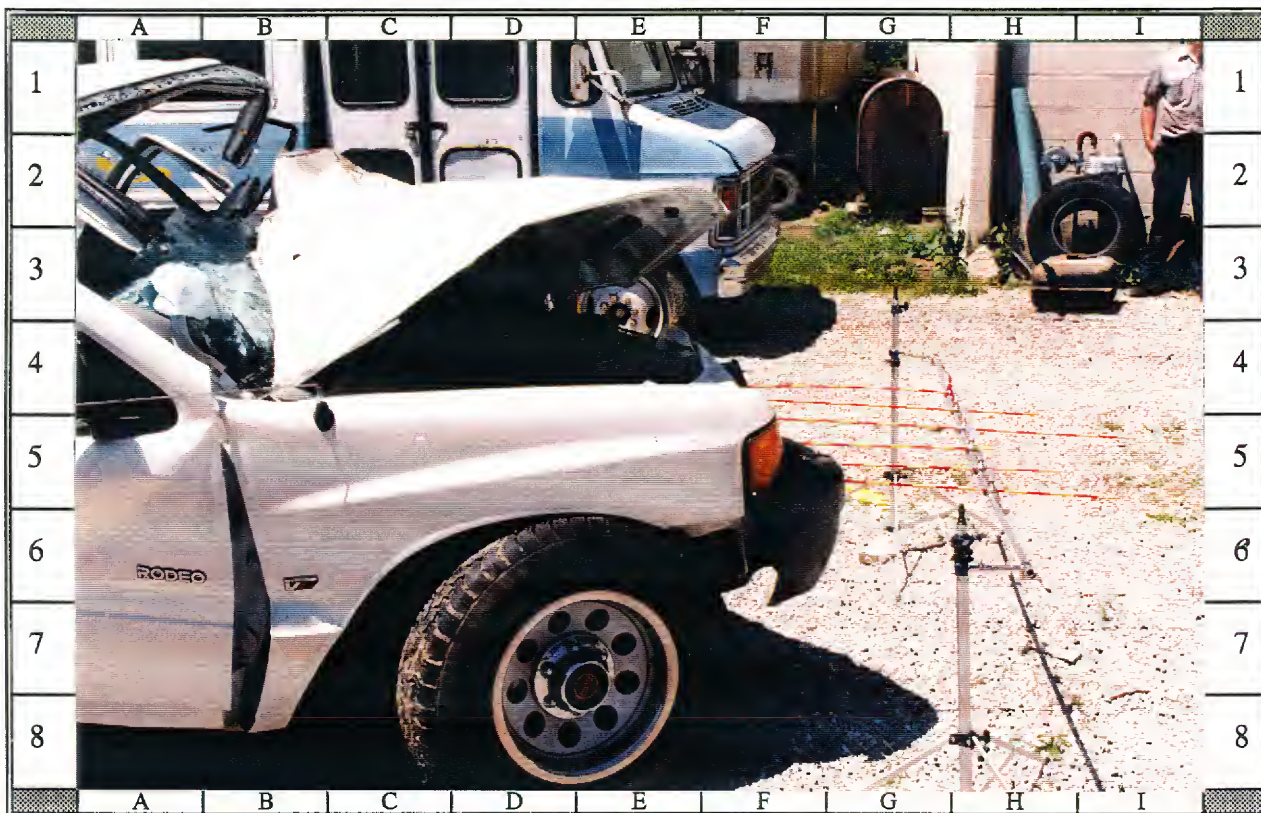
43: Reference line view of Case Vehicle's damaged front viewed from right; NOTE: leftward front end shift exposes lower right "A"-pillar area

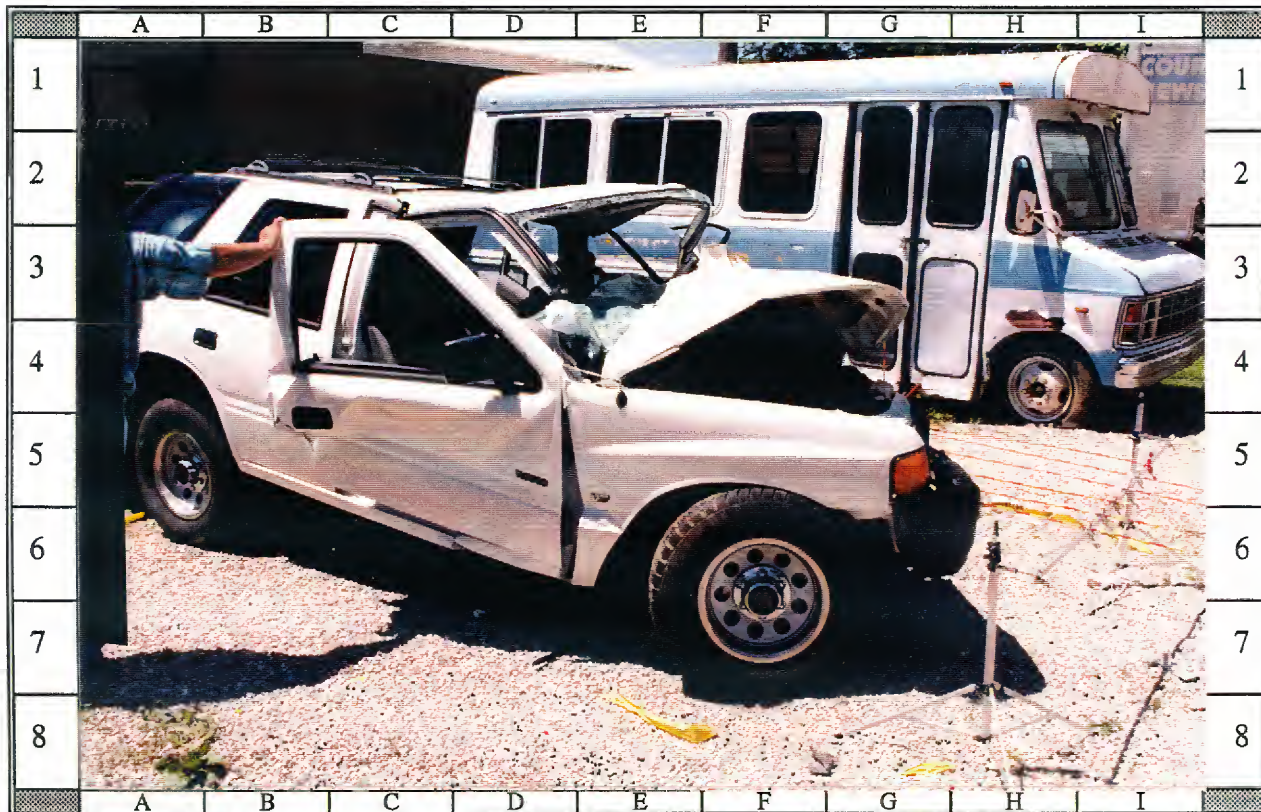
44: Case Vehicle's right side viewed from approximately 60 degrees right of front showing extrication tool-induced damage to right "A"-pillar at beltline

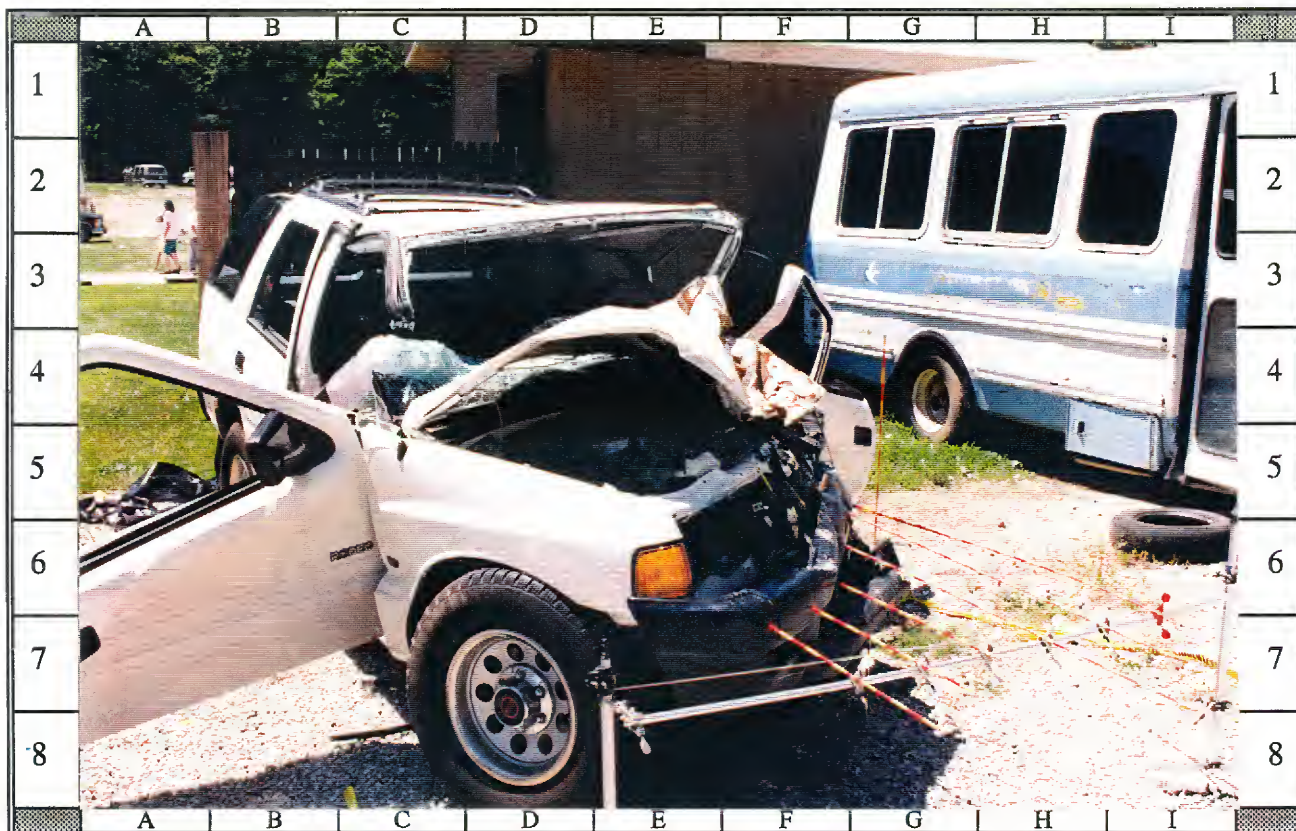
45: Case Vehicle's frontal damage with contour gauge present viewed from approximately 15 degrees right of front showing pronounced leftward front end shift

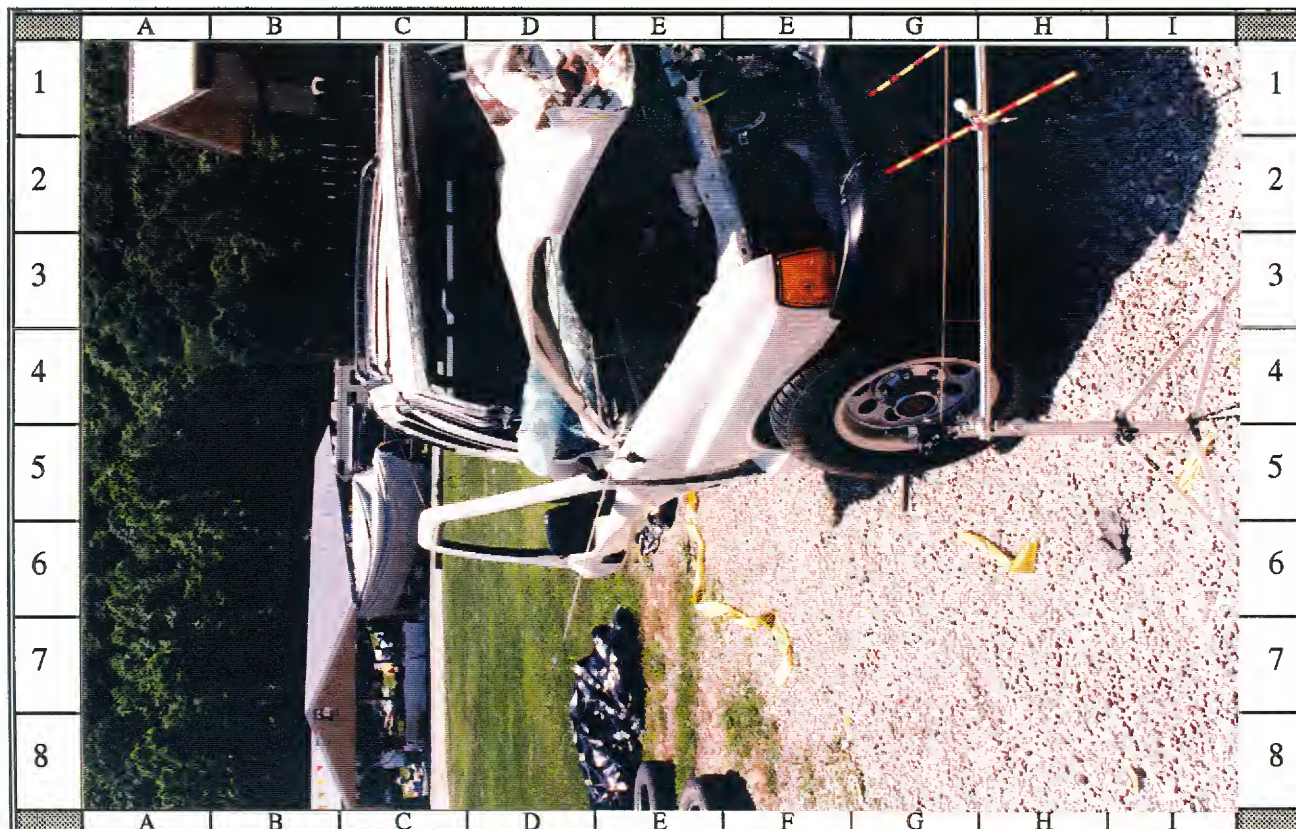
46: Reference line view of Case Vehicle's damaged front and right side viewed from front showing induced damage to right front fender and leftward front end shift
